Overview: The initial production release of the FTI-NSP2 harness has an issue where the POC1 circuit is incorrectly positioned in the CM7 I/O connector. This issue affects only the gray 20-pin CM7 I/O connector illustrated below in figure 1.

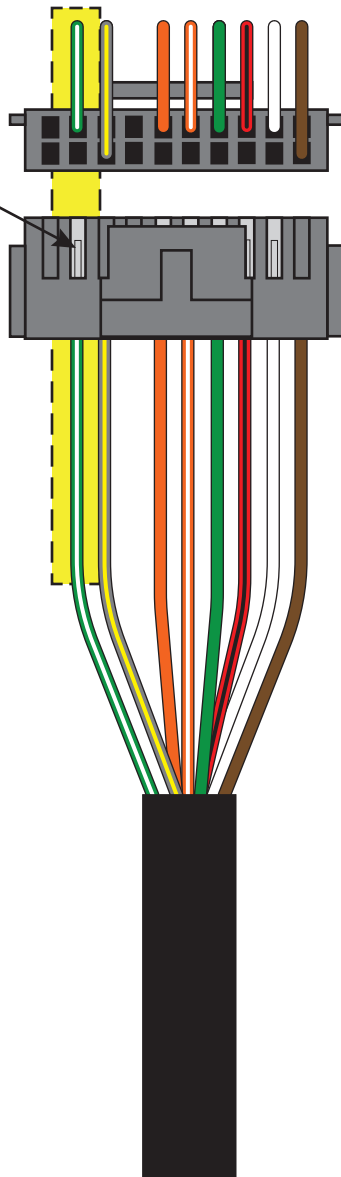
Issue: The green/white parking light circuit is positioned in pin position #17, the fixed light output where the green/white wire is typically placed for parking lights, but the harness solution uses the vehicle hazard lights instead, the result when used as supplied is an erratic light display.

Figure 1: Incorrect placement

- 1.) Use a pick tool to depress the locking tab on the terminal connector of the green/white wire
- 2.) Remove wire and prepare to reposition
- 3.) Once removed, reposition the locking tab by using a razor knife to lift the tab into a usable position
- 4.) With locking tab repositioned, relocate to pin position #1 (top right position as illustrated)
- 5.) Push the terminal connector into the I/O connector housing until the locking tab clicks into place and the wire is secure
- 6.) Correction complete, you may now complete the installation, but remember to configure POC1 for Hazards (setting #30)

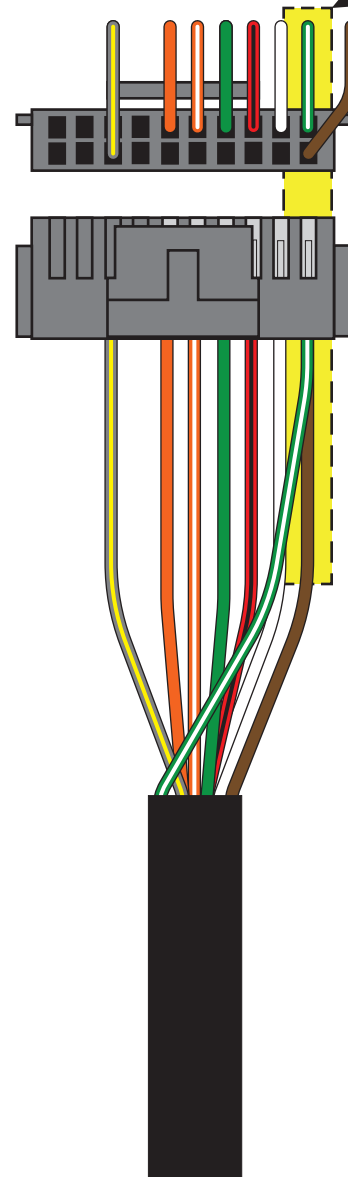
Figure 2: Corrected placement
