**Overview:** The initial production release of the FTI-TLK1 harness has an issue where in some vehicles the secondary power input to the CN1 connector will overload the associated vehicle circuit, causing a fuse to blow. This issue affects the initial release of harnesses and is already being addressed in production. A field correction procedure is detailed below in Figure 1.

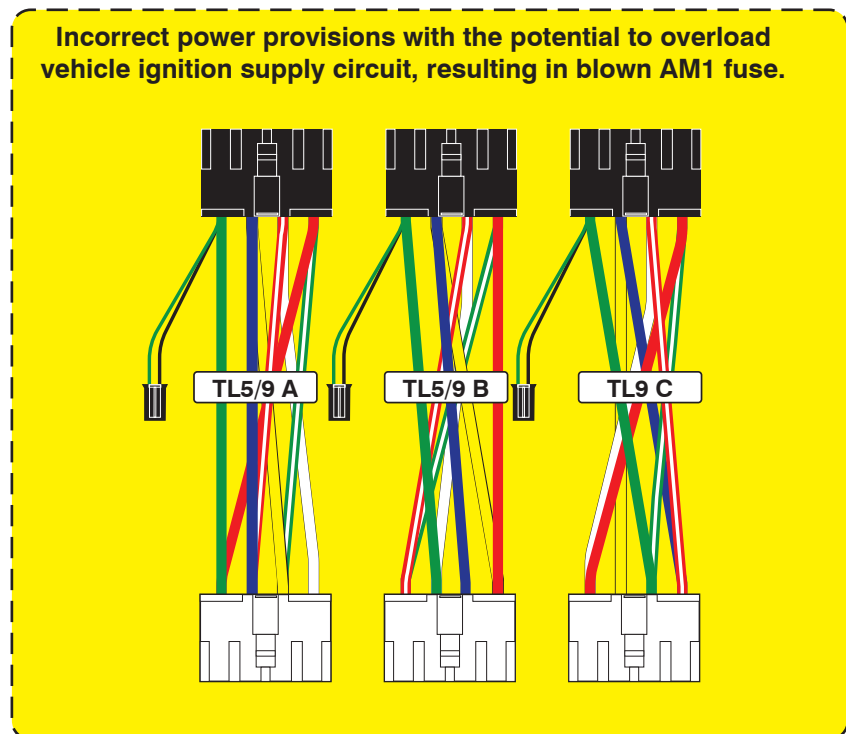
**Figure 2: Supplied CN1 Harness Adapters**

**Issue:** The secondary power circuit can overload some vehicle ignition switch circuits, causing a blown 5A/7.5A AM1 fuse, potentially disabling the vehicle and leaving the consumer stranded. Affected adapters are illustrated below in figure 2.
