Overview: Mis-Wired door lock connector, field repair required.

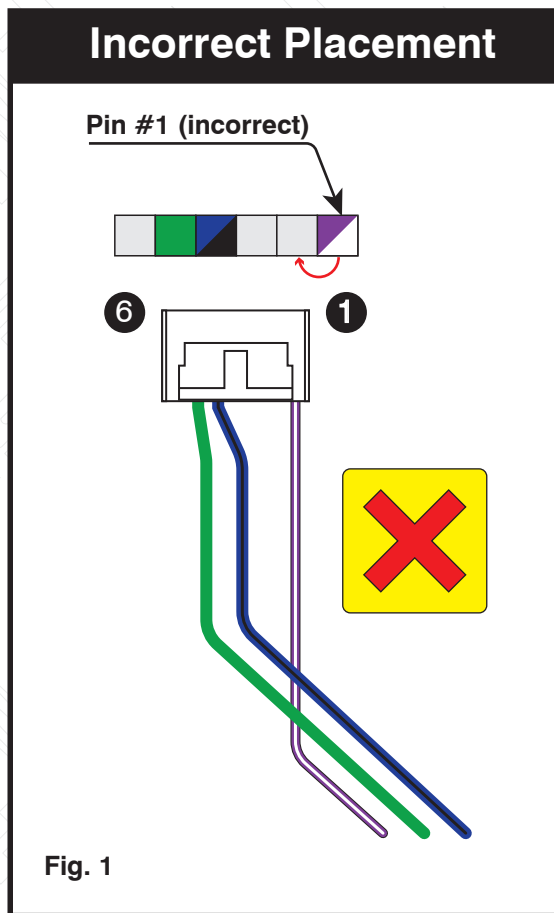
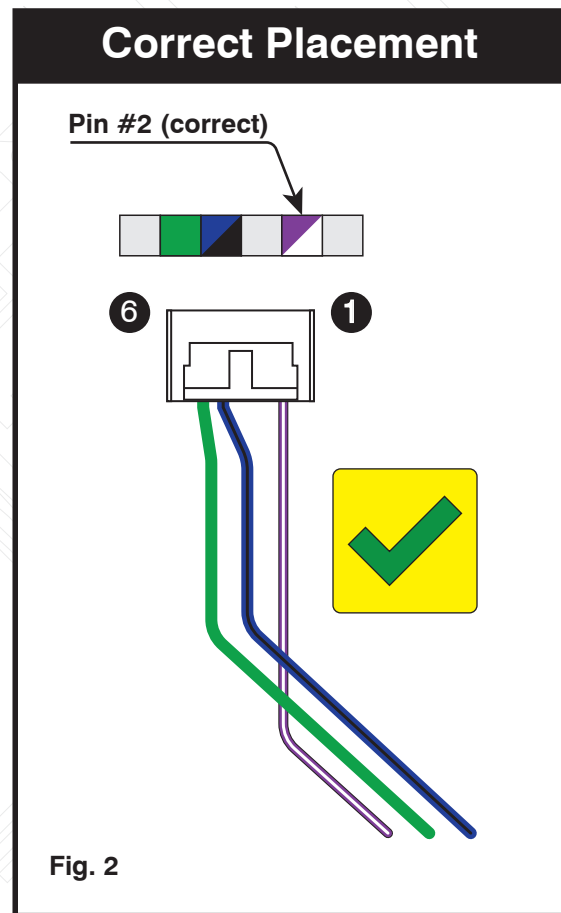
Issue: A review of the latest samples of **FTI-TLP4 T-harnesses** has revealed a misplaced trunk output wire in the 6-pin Lock Accessory Connector requiring that the wire be relocated to the correct position, to ensure safe operation when used. **Using the harness without addressing the issue will result in failed trunk/hatch control, and possible damage to the vehicle BCM.**

Correction: The harness purple/white wire in the latest production run of FTI-TLP4 harnesses has been inserted in the position normally used for the +12V power connection in the accessory harness. Before completing the installation, the installer must relocate the harness purple/white wire to the correct position, 1 space inward on the 6-pin connector, see illustrations below in Fig. 2.

To relocate the terminal, using a fine pick or Olfa type knife, depress the terminal locking barb and pull the purple/white wire from the connector housing. Once the terminal has been removed from the housing, again using the pick or knife, lift the locking barb about 1/16" (1.5 mm) and reinsert the terminal in the correct position. If upon initial examination of the harness the lock accessory connector looks like the illustration in Fig. 2, no modification is necessary, the wire is in the proper position.
