**Overview:** Mis-Wired door lock connector, field repair required.

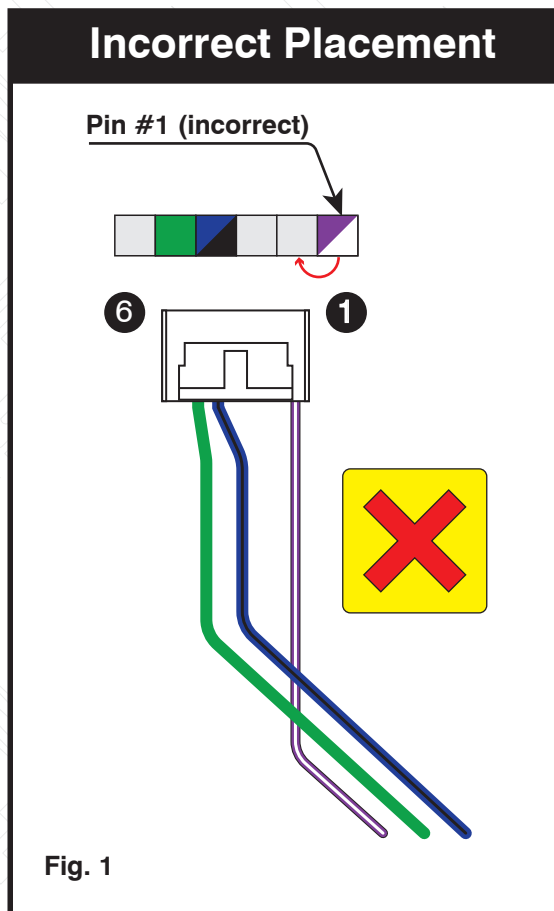
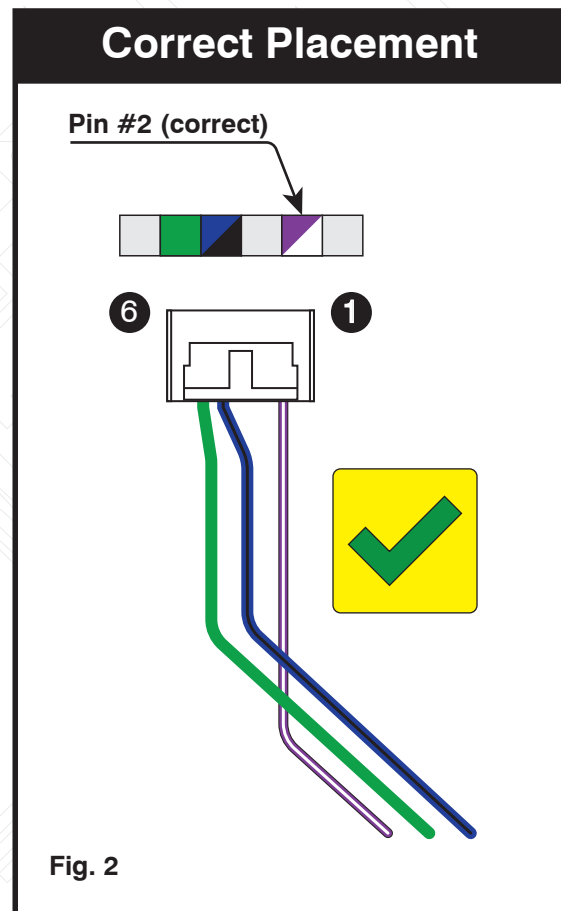
**Issue:** A review of the latest samples of **FTI-TLP4 T-harnesses** has revealed a misplaced trunk output wire in the 6-pin Lock Accessory Connector requiring that the wire be relocated to the correct position, to ensure safe operation when used. **Using the harness without addressing the issue will result in failed trunk/hatch control, and possible damage to the vehicle BCM.**

**Correction:** The harness purple/white wire in the latest production run of FTI-TLP4 harnesses has been inserted in the position normally used for the +12V power connection in the accessory harness. Before completing the installation, the installer must relocate the harness purple/white wire to the correct position, 1 space inward on the 6-pin connector, see illustrations below in Fig. 2.

To relocate the terminal, using a fine pick or Olfa type knife, depress the terminal locking barb and pull the purple/white wire from the connector housing. Once the terminal has been removed from the housing, again using the pick or knife, lift the locking barb about 1/16" (1.5 mm) and reinsert the terminal in the correct position. If upon initial examination of the harness the lock accessory connector looks like the illustration in Fig. 2, no modification is necessary, the wire is in the proper position.
