F RSTECH, LLC. SUPPORT - 1(888) 820-3690, EXT. 203

FTI-TLK1 Type 3B4 - Vehicle Coverage & Preparation Notes

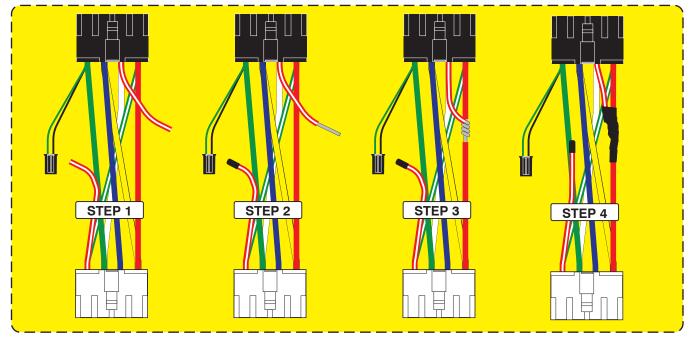
Figure 1: Step by step adapter correction

Overview: The initial production release of the FTI-TLK1 harness has an issue where in some vehicles the secondary power input to the CN1 connector will overload the associated vehicle circuit, causing a fuse to blow. This issue affects the initial release of harnesses and is already being addressed in production. A field correction procedure is detailed below in Figure 1.

- 1.) Select the applicable CN1 adapter, isolate the RED/WHITE power wire, cut wire approximately 4" from the BLACK plug
- 2.) Insulate the wire still connected to the WHITE plug using heat shrink tubing, and strip the insulation on the other wire end
- 3.) Strip a portion of the insulation from the RED wire, attach the stripped RED/WHITE to the exposed RED wire, solder together
- 4.) Apply insulating tape to the soldered connection and secure the cut ends back to the bundle of wires created by the adapter
- 5.) Correction complete, you may safely proceed to finish your installation

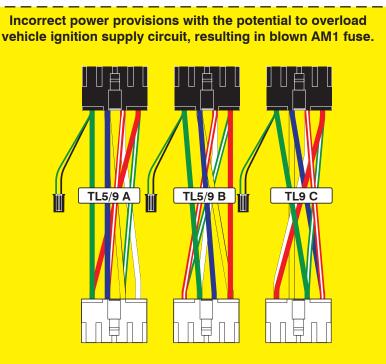
Figure 2: Supplied CN1 Harness Adapters

Issue: The secondary power circuit can overload some vehicle ignition switch circuits, causing a blown 5A/7.5A AM1 fuse, potentially disabling the vehicle and leaving the consumer stranded. Affected adapters are illustrated below in figure 2.
