## FTI-TLK1 Harness Bulletin - Mis-wired Power Circuits

## FTI-TLK1 Type 3C3 - Vehicle Coverage & Preparation Notes

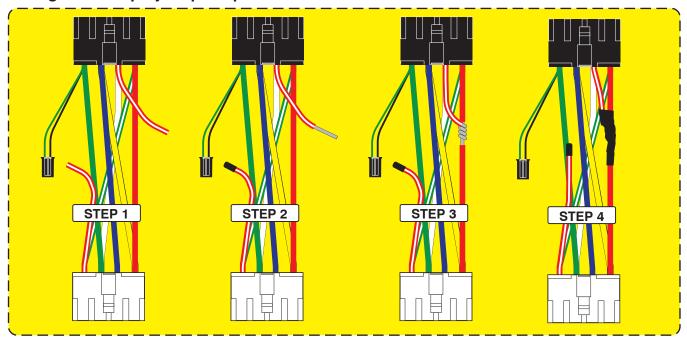
Figure 1: Step by step adapter correction

Overview: The initial production release of the FTI-TLK1 harness has an issue where in some vehicles the secondary power input to the CN1 connector will overload the associated vehicle circuit, causing a fuse to blow. This issue affects the initial release of harnesses and is already being addressed in production. A field correction procedure is detailed below in Figure 1.

- 1.) Select the applicable CN1 adapter, isolate the RED/WHITE power wire, cut wire approximately 4" from the BLACK plug
- 2.) Insulate the wire still connected to the WHITE plug using heat shrink tubing, and strip the insulation on the other wire end
- 3.) Strip a portion of the insulation from the RED wire, attach the stripped RED/WHITE to the exposed RED wire, solder together
- 4.) Apply insulating tape to the soldered connection and secure the cut ends back to the bundle of wires created by the adapter
- 5.) Correction complete, you may safely proceed to finish your installation

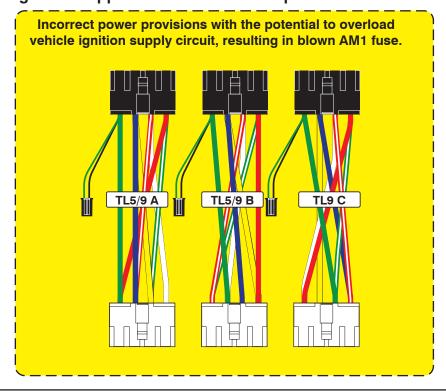
Figure 2: Supplied CN1 Harness Adapters

Issue: The secondary power circuit can overload some vehicle ignition switch circuits, causing a blown 5A/7.5A AM1 fuse, potentially disabling the vehicle and leaving the consumer stranded. Affected adapters are illustrated below in figure 2.
