FTI-NSP2 Type 2 - Vehicle Coverage & Preparation Notes

FTI-NSP2 Type 2

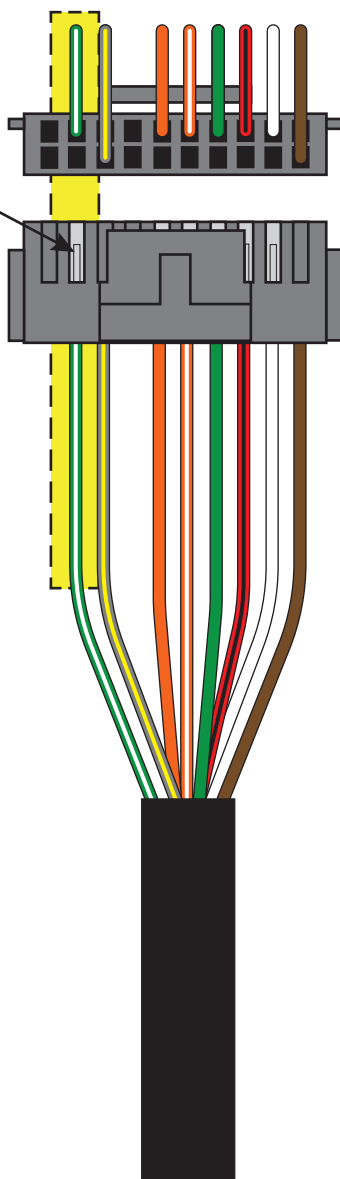
Figure 1: Incorrect placement

Overview: The initial production release of the FTI-NSP2 harness has an issue where the POC1 circuit is incorrectly positioned in the CM7 I/O connector. This issue affects only the gray 20-pin CM7 I/O connector illustrated below in figure 1.

Issue: The green/white parking light circuit is positioned in pin position #17, the fixed light output where the green/white wire is typically placed for parking lights, but the harness solution uses the vehicle hazard lights instead, the result when used as supplied is an erratic light display.

- 1.) Use a pick tool to depress the locking tab on the terminal connector of the green/white wire
- 2.) Remove wire and prepare to reposition
- 3.) Once removed, reposition the locking tab by using a razor knife to lift the tab into a usable position
- 4.) With locking tab repositioned, relocate to pin position #1 (top right position as illustrated)
- 5.) Push the terminal connector into the I/O connector housing until the locking tab clicks into place and the wire is secure
- 6.) Correction complete, you may now complete the installation, but remember to configure POC1 for Hazards (setting #30)
