Make	Model	Year	Install	CAN	Lights	BCM	POC1	I/O Changes
DL-NI8					Park / Auto			Green White/Blue
Infiniti	QX50 PTS	2019-21	Type 2	BCM	POC 1	DSD	Hazard 1/2

FTI-NSP2 Type 2 - Installation Notes & Wiring Diagram

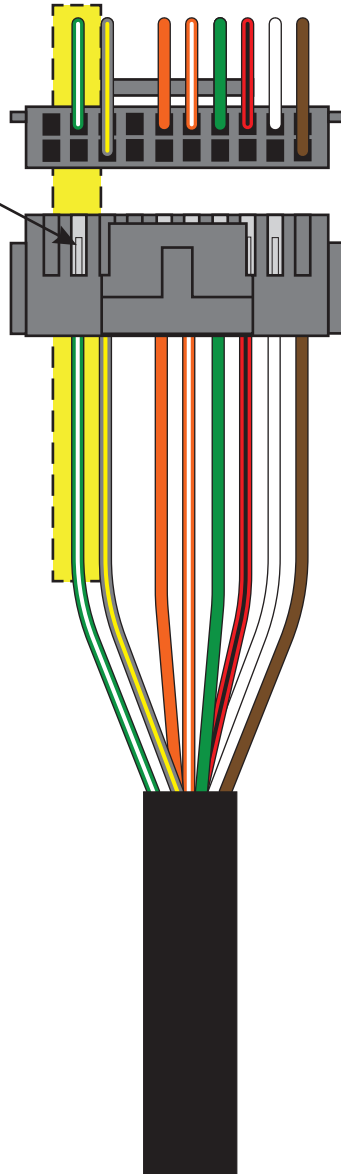
Figure 1: Incorrect placement

Overview: The initial production release of the FTI-NSP2 harness has an issue where the POC1 circuit is incorrectly positioned in the CM7 I/O connector. This issue affects only the gray 20-pin CM7 I/O connector illustrated below in figure 1.

Issue: The green/white parking light circuit is positioned in pin position #17, the fixed light output where the green/white wire is typically placed for parking lights, but the harness solution uses the vehicle hazard lights instead, the result when used as supplied is an erratic light display.

- 1.) Use a pick tool to depress the locking tab on the terminal connector of the green/white wire
- 2.) Remove wire and prepare to reposition
- 3.) Once removed, reposition the locking tab by using a razor knife to lift the tab into a usable position
- 4.) With locking tab repositioned, relocate to pin position #1 (top right position as illustrated)
- 5.) Push the terminal connector into the I/O connector housing until the locking tab clicks into place and the wire is secure
- 6.) Correction complete, you may now complete the installation, but remember to configure POC1 for Hazards (setting #30)
