| Make | Model | Year | Install | CAN | Lights | BCM | POC1 | I/O Changes |
|---|---|---|---|---|---|---|---|---|
| Infiniti | QX50 PTS | 2019 | Type 2 | BCM | CM I/O | DSD | Hazard1/2 | |

FTI-NSP2 Type 2 - Installation Notes & Wiring Diagram

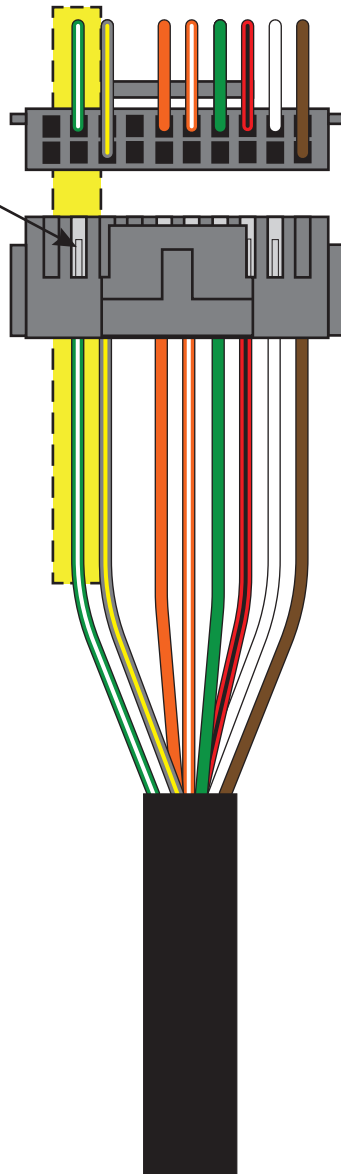
Figure 1: Incorrect placement

Overview: The initial production release of the FTI-NSP2 harness has an issue where the POC1 circuit is incorrectly positioned in the CM7 I/O connector. This issue affects only the gray 20-pin CM7 I/O connector illustrated below in figure 1.

Issue: The green/white parking light circuit is positioned in pin position #17, the fixed light output where the green/white wire is typically placed for parking lights, but the harness solution uses the vehicle hazard lights instead, the result when used as supplied is an erratic light display.

- 1.) Use a pick tool to depress the locking tab on the terminal connector of the green/white wire
- 2.) Remove wire and prepare to reposition
- 3.) Once removed, reposition the locking tab by using a razor knife to lift the tab into a usable position
- 4.) With locking tab repositioned, relocate to pin position #1 (top right position as illustrated)
- 5.) Push the terminal connector into the I/O connector housing until the locking tab clicks into place and the wire is secure
- 6.) Correction complete, you may now complete the installation, but remember to configure POC1 for Hazards (setting #30)
