# FTI-NSP2 Type 2 - Vehicle Coverage & Preparation Notes

# FTI-NSP2 Harness Bulletin - Mis-wired POC1 (parking lights)

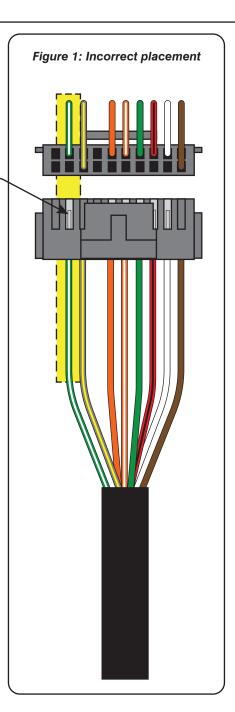
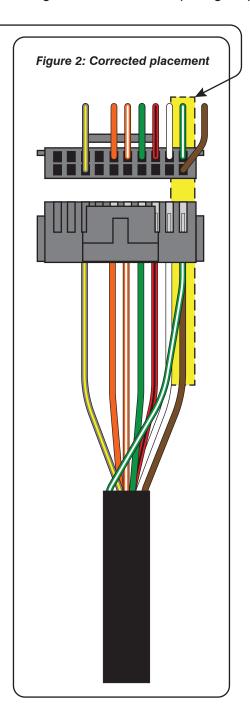
Overview: The initial production release of the FTI-NSP2 harness has an issue where the POC1 circuit is incorrectly positioned in the CM7 I/O connector. This issue affects only the gray 20-pin CM7 I/O connector illustrated below in figure 1.

Issue: The green/white parking light circuit is positioned in pin position #17, the fixed light output where the green/white wire is typically placed for parking lights, but the harness solution uses the vehicle hazard lights instead, the result when used as supplied is an erratic light display.

- 1.) Use a pick tool to depress the locking tab on the terminal connector of the green/white wire
- 2.) Remove wire and prepare to reposition
- 3.) Once removed, reposition the locking tab by using a razor knife to lift the tab into a usable position
- 4.) With locking tab repositioned, relocate to pin position #1 (top right position as illustrated)
- 5.) Push the terminal connector into the I/O connector housing until the locking tab clicks into place and the wire is secure
- 6.) Correction complete, you may now complete the installation, but remember to configure POC1 for Hazards (setting #30)
