**Overview:** The initial production release of the FTI-TLK1 harness has an issue where in some vehicles the secondary power input to the CN1 connector will overload the associated vehicle circuit, causing a fuse to blow. This issue affects the initial release of harnesses and is already being addressed in production. A field correction procedure is detailed below in Figure 1.

# FTI-TLK1 Type 1B - Vehicle Coverage & Preparation Notes

# FTI-TLK1 Type 1B - Installation Notes & Wiring Diagram

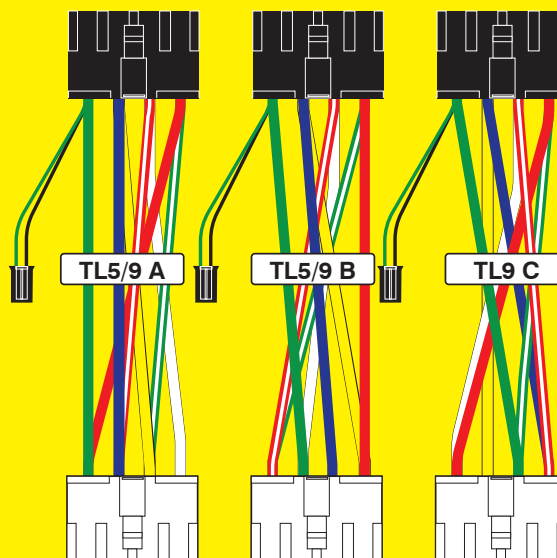
**Figure 2: Supplied CN1 Harness Adapters**

**Issue:** The secondary power circuit can overload some vehicle ignition switch circuits, causing a blown 5A/7.5A AM1 fuse, potentially disabling the vehicle and leaving the consumer stranded. Affected adapters are illustrated below in figure 2.

Incorrect power provisions with the potential to overload vehicle ignition supply circuit, resulting in blown AM1 fuse.
