FTI-NSP2 Type 2 - Vehicle Coverage & Preparation Notes

FTI-NSP2 Type 2

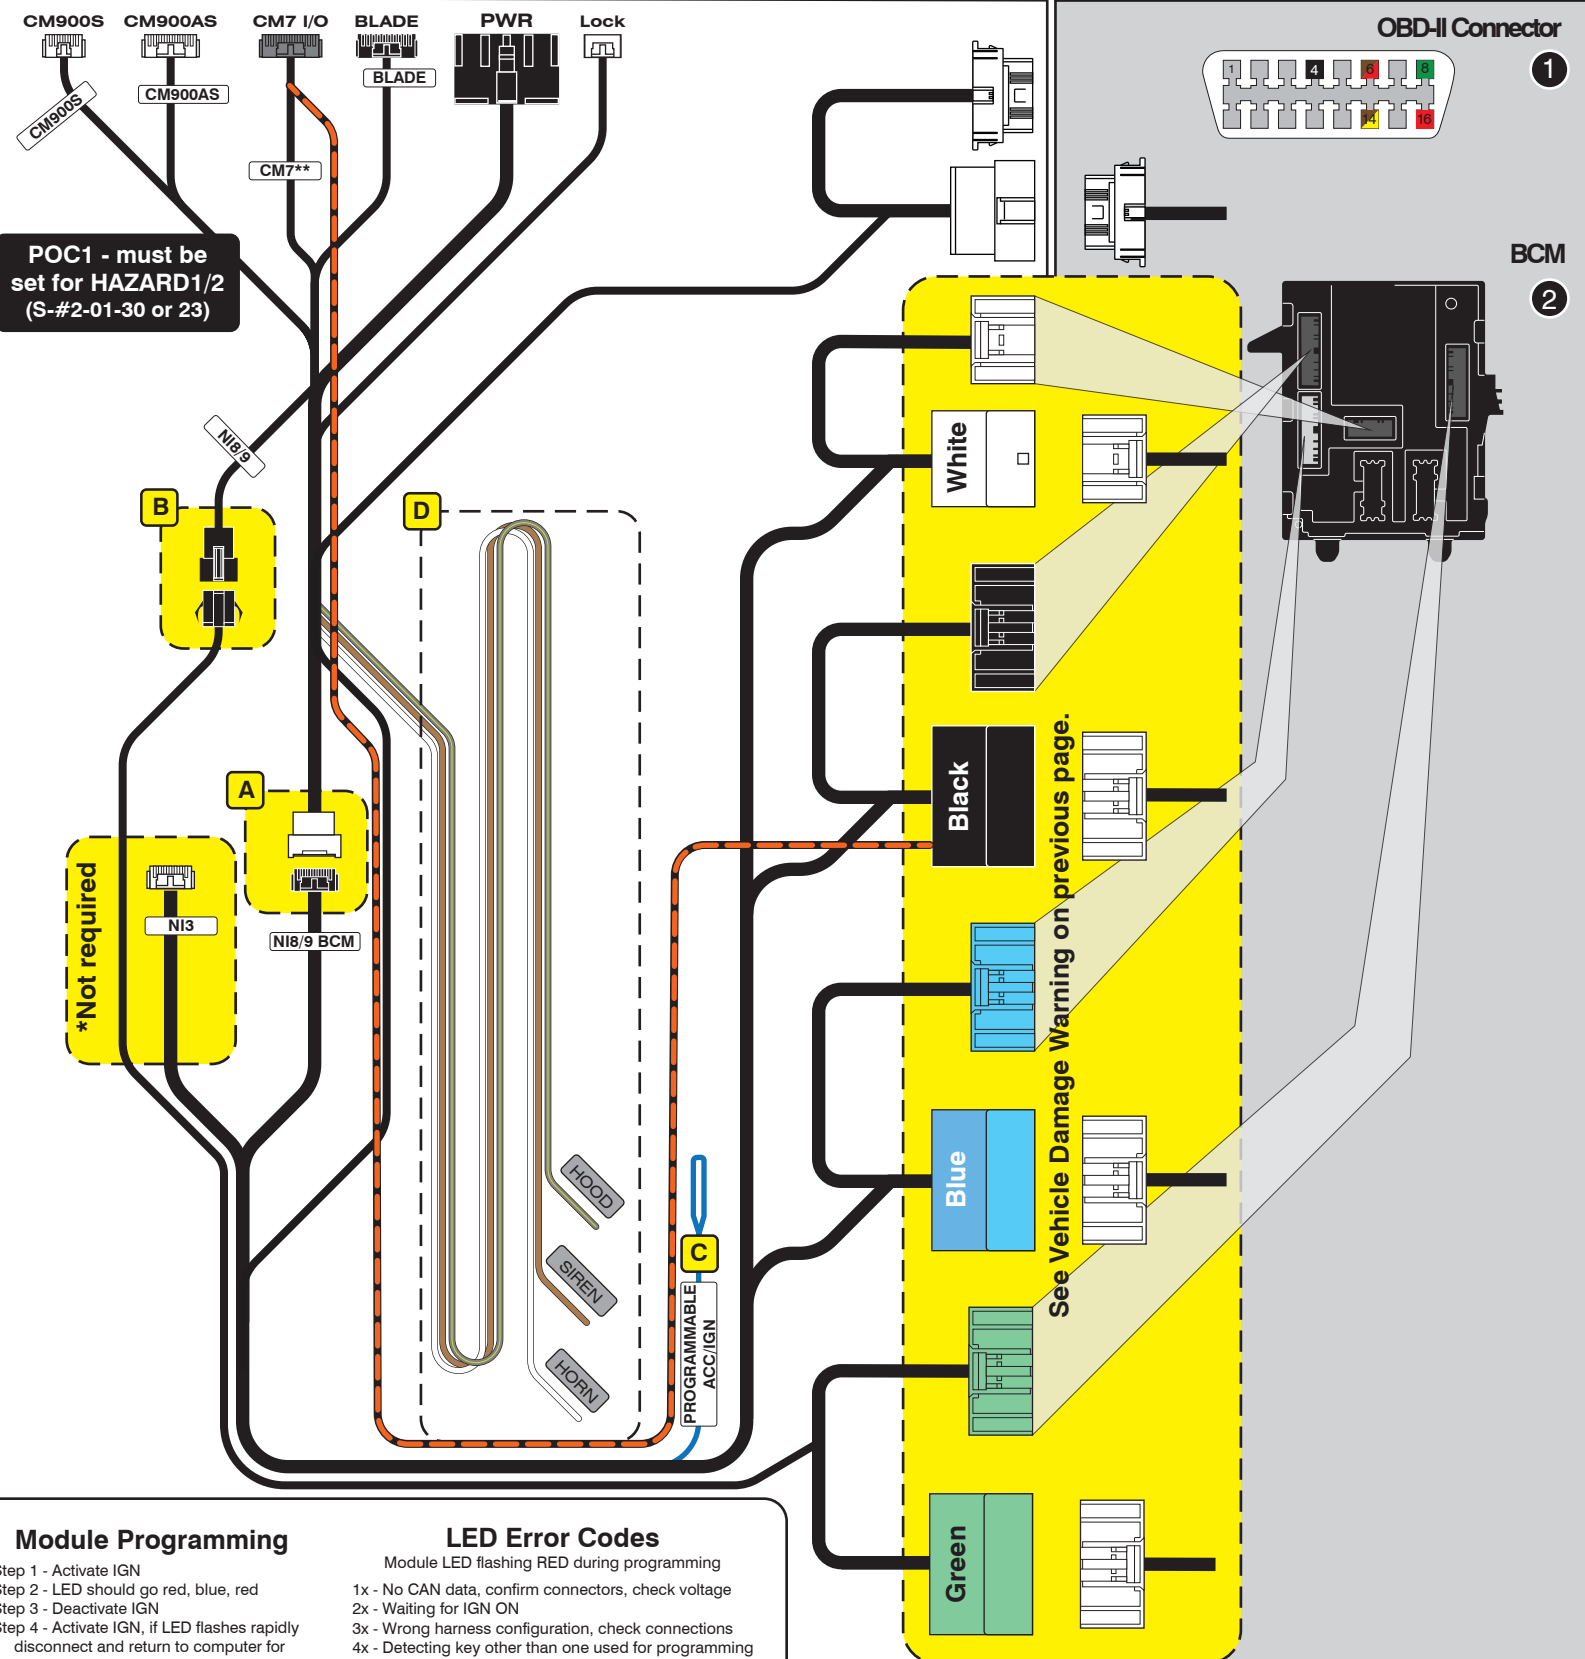
- A** Confirm that NI8 cable connection (BLACK 14-pin male to WHITE 14-PIN female) is selected prior to making connections to vehicle. Secure unused NI3 connector to ensure against short circuits.
- B** Intermediate NI8/9 BCM CAN connector, secure to main harness body and route toward BCM along with main harness.
- C** Programmable ACC/IGN output from CN1 BLUE wire, not used in NI8 applications, either cut short or fold back and insulate using tape. Secure to harness body to ensure against short circuits.
- D** HOOD, SIREN, and HORN connections from CM I/O connector, use as needed

Issue: The green/white parking light circuit is positioned in pin position #17, the fixed light output where the green/white wire is typically placed for parking lights, but the harness solution uses the vehicle hazard lights instead, the result when used as supplied is an erratic light display.

- 1.) Use a pick tool to depress the locking tab on the terminal connector of the green/white wire
- 2.) Remove wire and prepare to reposition
- 3.) Once removed, reposition the locking tab by using a razor knife to lift the tab into a usable position
- 4.) With locking tab repositioned, relocate to pin position #1 (top right position as illustrated)
- 5.) Push the terminal connector into the I/O connector housing until the locking tab clicks into place and the wire is secure
- 6.) Correction complete, you may now complete the installation, but remember to configure POC1 for Hazards (setting #30)
