Overview: Mis-Wired door lock connector, field repair required.

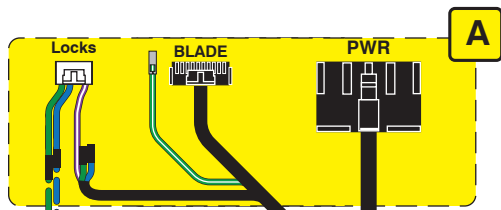
Door Lock Connections

Issue: A review of the latest samples of **FTI-TLP4 T-harnesses** has revealed a misplaced trunk output wire in the 6-pin Lock Accessory Connector requiring that the wire be relocated to the correct position, to ensure safe operation when used. **Using the harness without addressing the issue will result in failed trunk/hatch control, and possible damage to the vehicle BCM.**

Correction: The harness purple/white wire in the latest production run of FTI-TLP4 harnesses has been inserted in the position normally used for the +12V power connection in the accessory harness. Before completing the installation, the installer must relocate the harness purple/white wire to the correct position, 1 space inward on the 6-pin connector, see illustrations below in Fig. 2.

To relocate the terminal, using a fine pick or Olfa type knife, depress the terminal locking barb and pull the purple/white wire from the connector housing. Once the terminal has been removed from the housing, again using the pick or knife, lift the locking barb about 1/16" (1.5 mm) and reinsert the terminal in the correct position. If upon initial examination of the harness the lock accessory connector looks like the illustration in Fig. 2, no modification is necessary, the wire is in the proper position.
