Make	Model	Year	Install	CAN	Lights	BCM	POC1	I/O Changes
DL-NI8					Park / Auto			Green White/Blue
Infiniti	QX50 PTS	2019-21	Type 2	BCM	POC 1	DSD	Hazard 1/2

FTI-NSP2 Type 2 - Installation Notes & Wiring Diagram

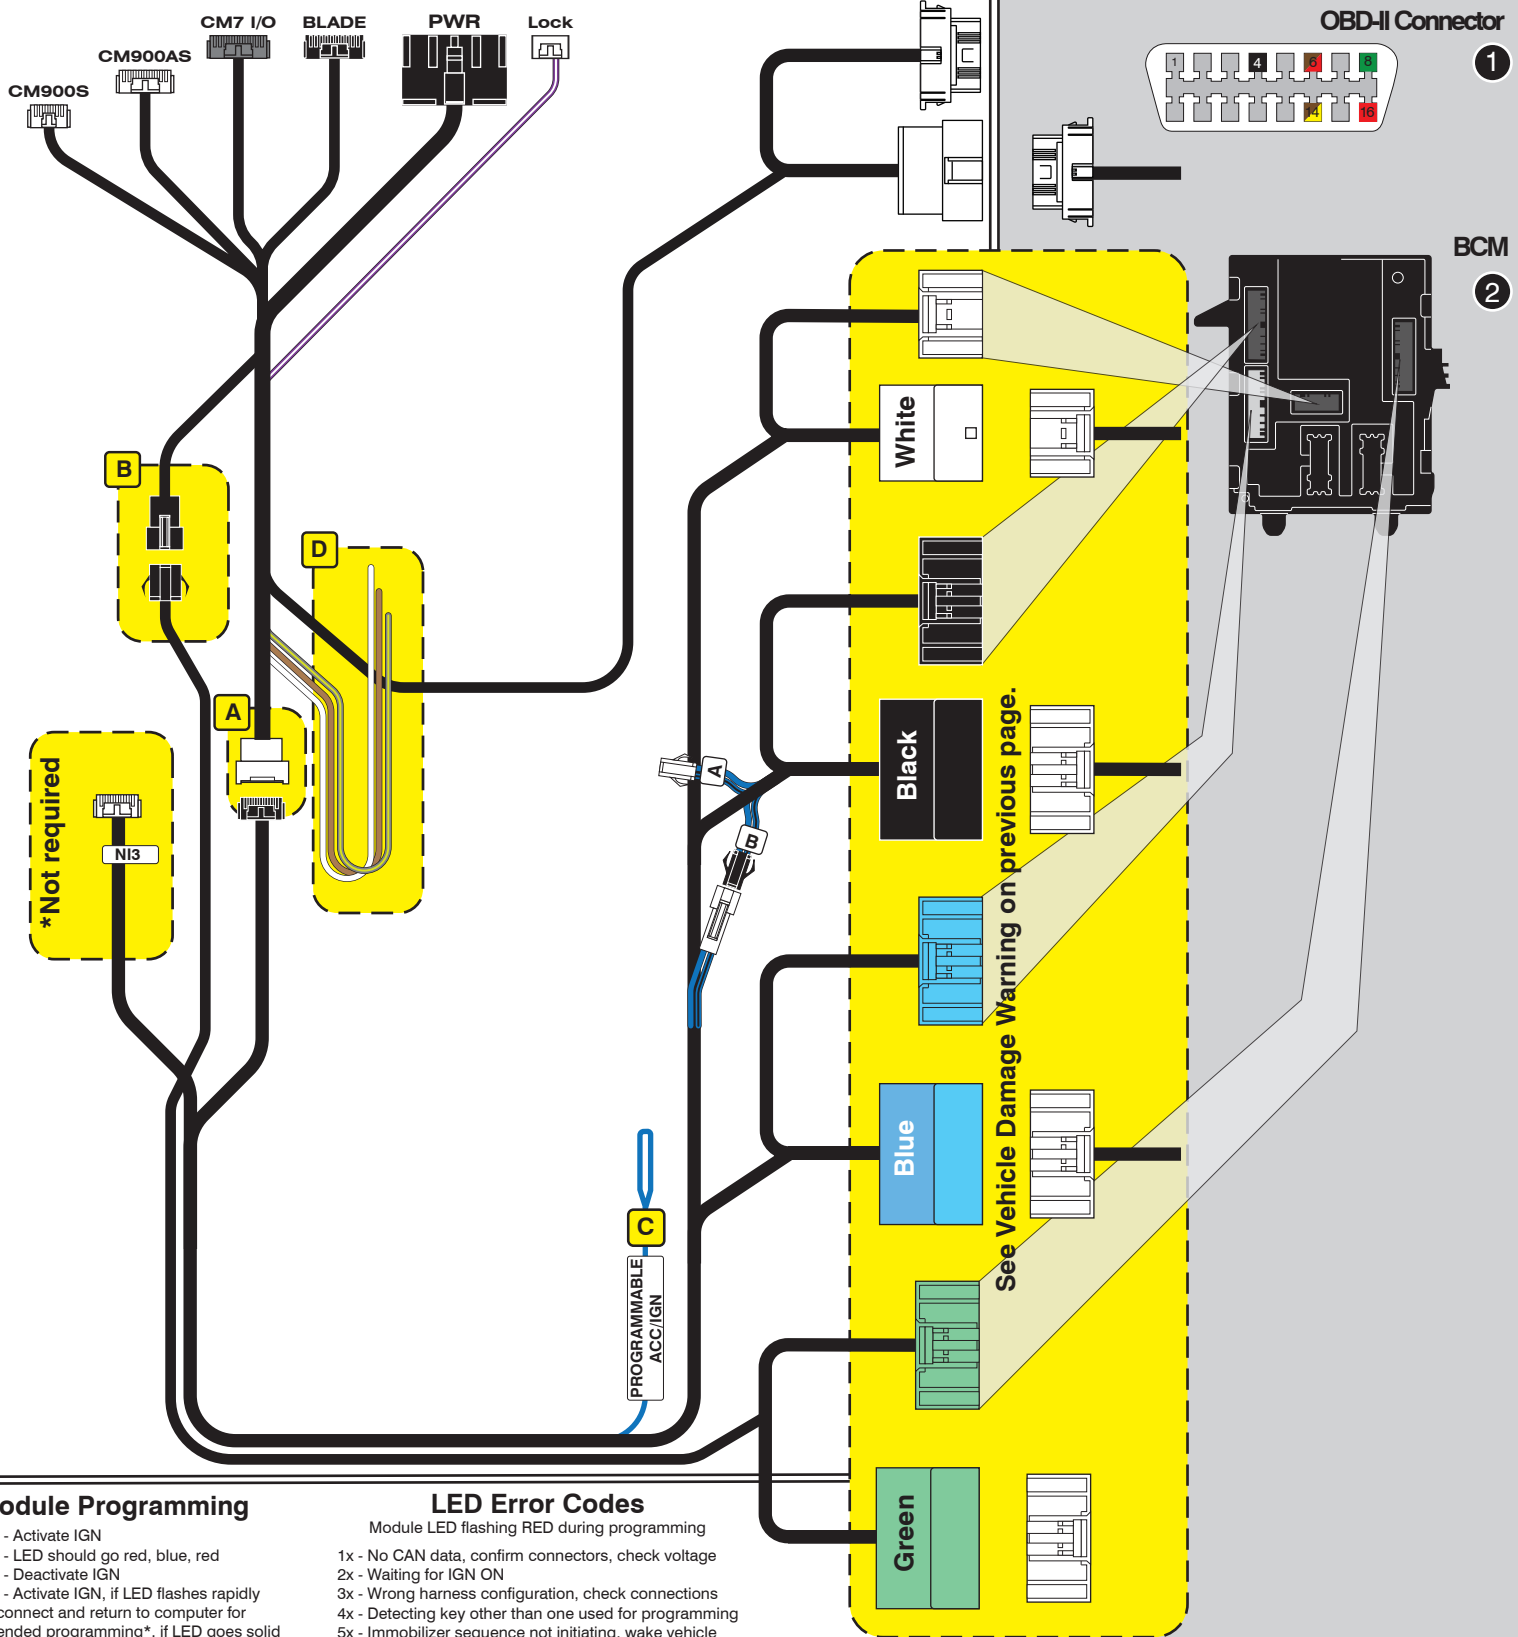
- A** Confirm that NI8 cable connection (BLACK 14-pin male to WHITE 14-PIN female) is selected prior to making connections to vehicle. Secure unused NI3 connector to ensure against short circuits.
- B** Intermediate NI8/9 BCM CAN connector, secure to main harness body and route toward BCM along with main harness.
- C** Programmable ACC/IGN output from CN1 BLUE wire, not used in NI8 applications, either cut short or fold back and insulate using tape. Secure to harness body to ensure against short circuits.
- D** HOOD, SIREN, and HORN connections from CM I/O connector, use as needed
