| Make | Model | Year | Install | CAN | Lights | BCM | POC1 | I/O Changes |
|---|---|---|---|---|---|---|---|---|
| Infiniti | QX50 PTS | 2019 | Type 2 | BCM | CM I/O | DSD | Hazard1/2 | |

FTI-NSP2 Type 2 - Installation Notes & Wiring Diagram

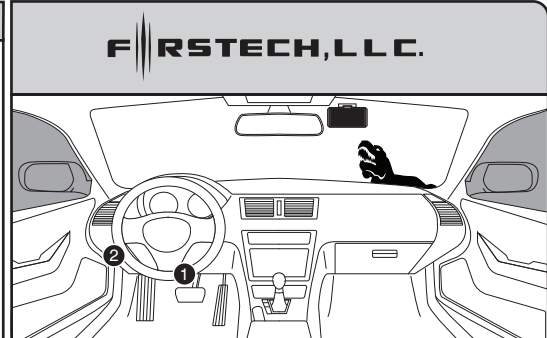
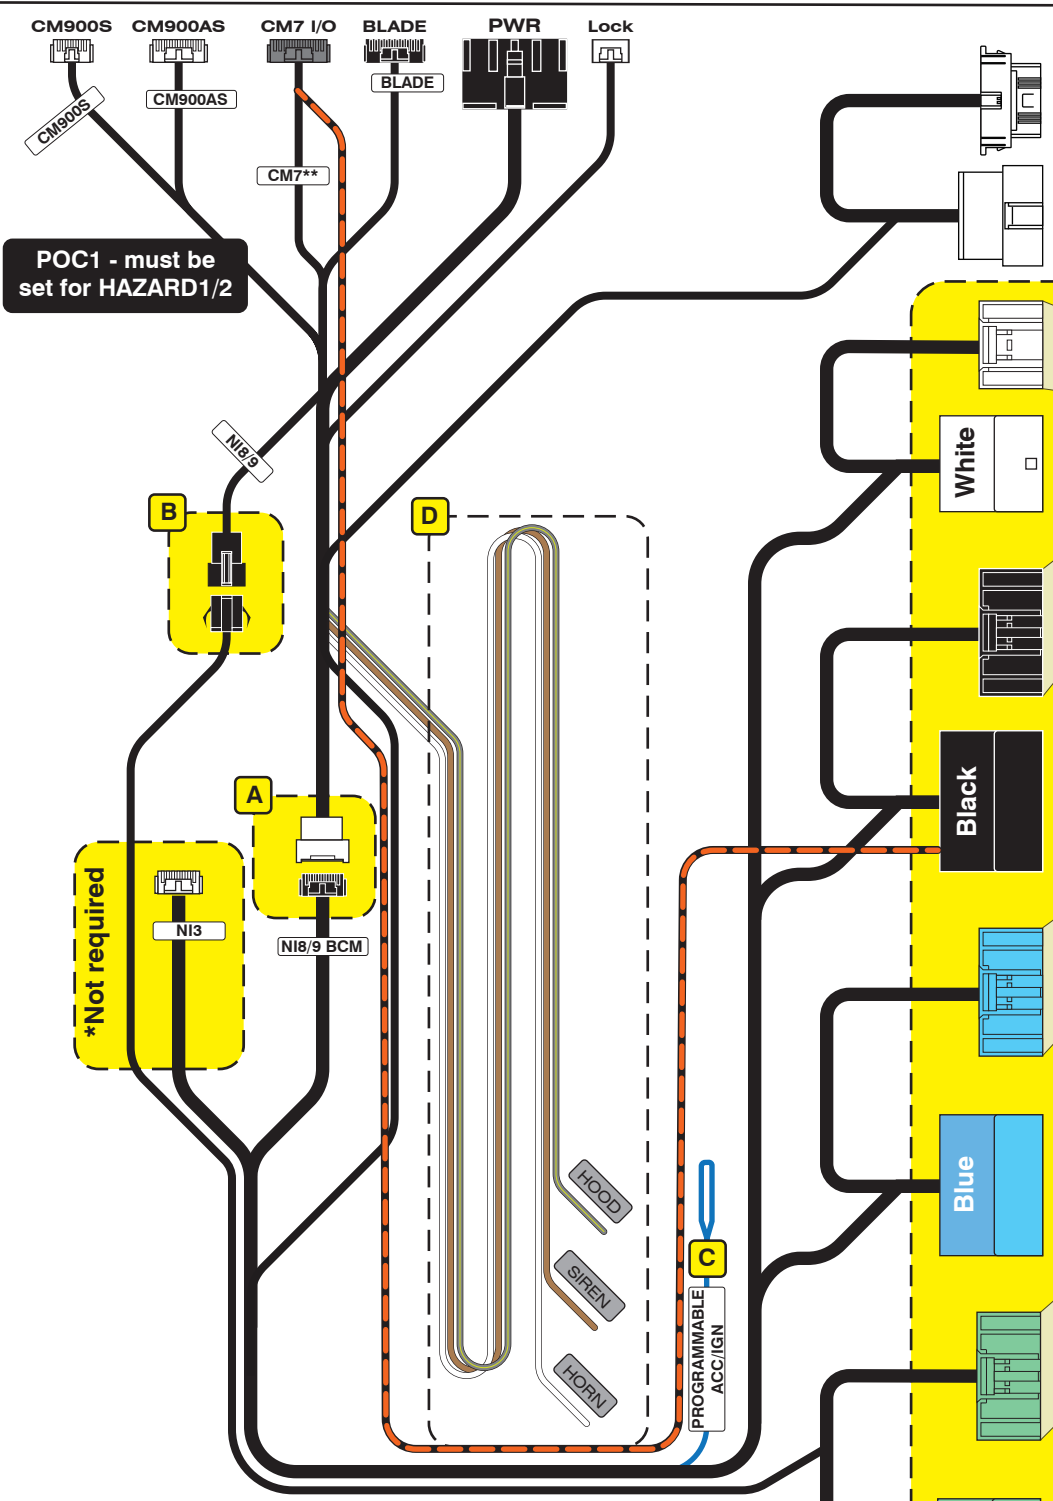
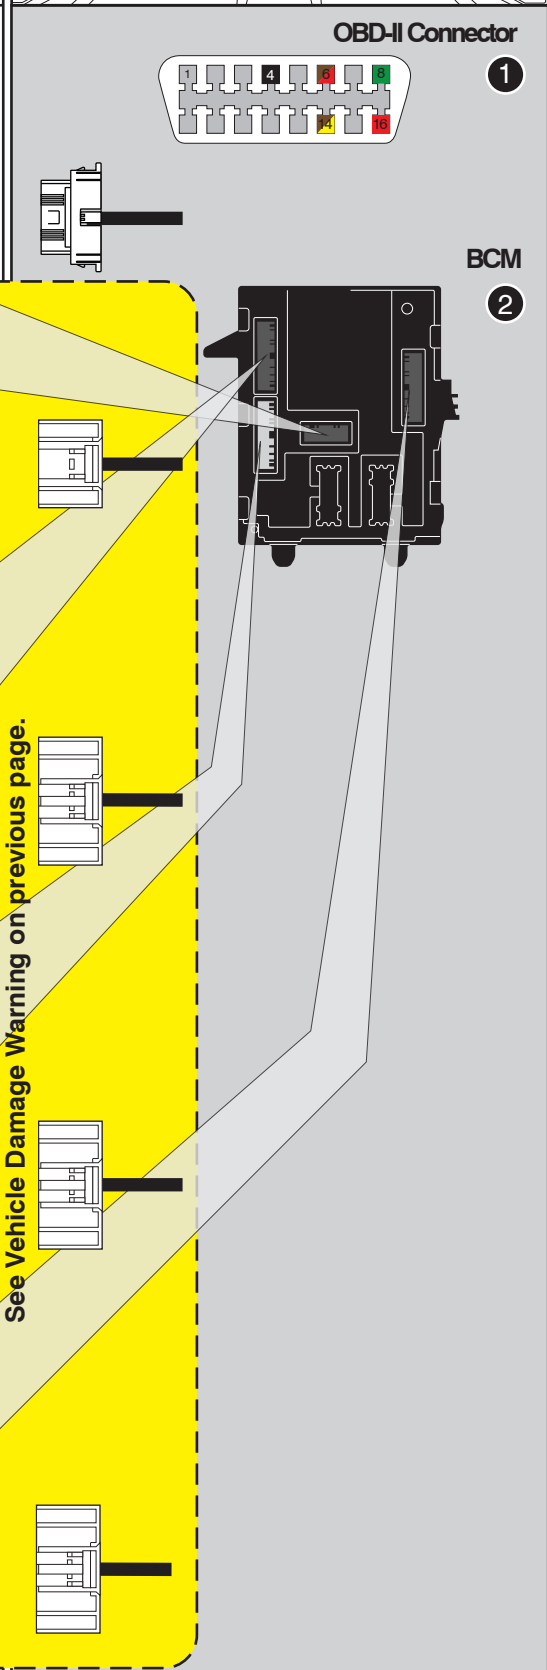
- A** Confirm that NI8 cable connection (BLACK 14-pin male to WHITE 14-PIN female) is selected prior to making connections to vehicle. Secure unused NI3 connector to ensure against short circuits.
- B** Intermediate NI8/9 BCM CAN connector, secure to main harness body and route toward BCM along with main harness.
- C** Programmable ACC/IGN output from CN1 BLUE wire, not used in NI8 applications, either cut short or fold back and insulate using tape. Secure to harness body to ensure against short circuits.
- D** HOOD, SIREN, and HORN connections from CM I/O connector, use as needed
