# FTI-NSP2 Type 2 - Vehicle Coverage & Preparation Notes

# FTI-NSP2 Harness Bulletin - Mis-wired POC1 (parking lights)

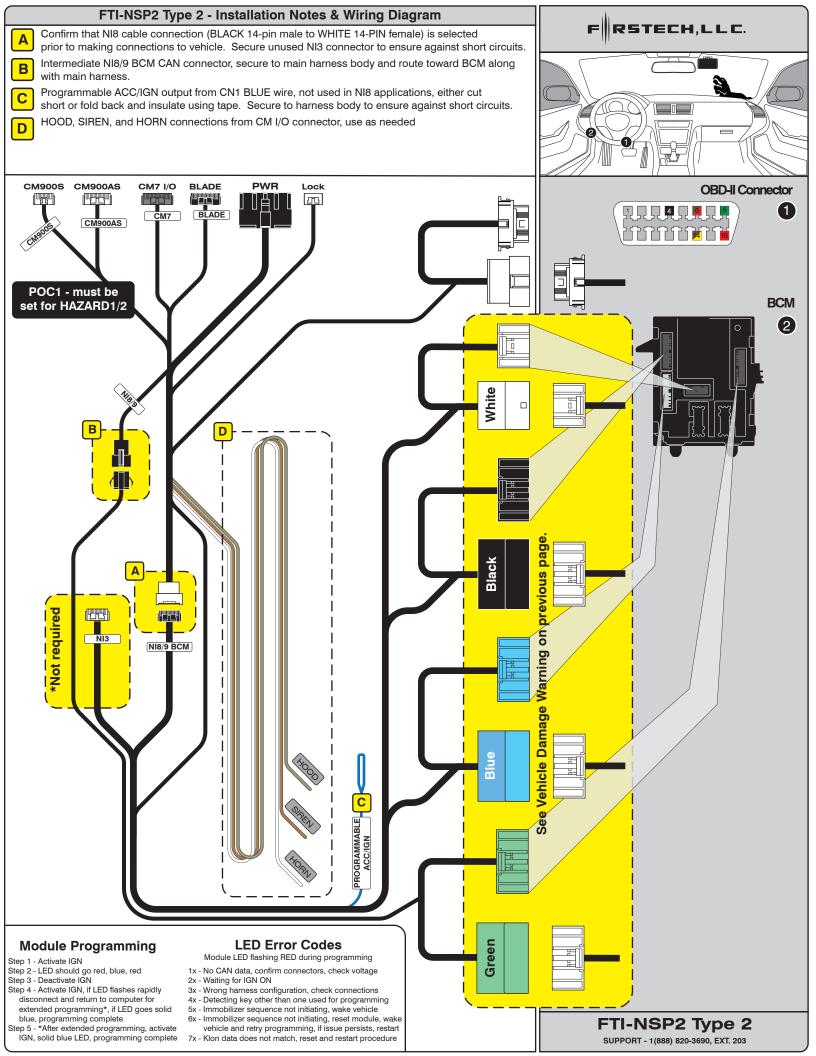
Issue: The green/white parking light circuit is positioned in pin position #17, the fixed light output where the green/white wire is typically placed for parking lights, but the harness solution uses the vehicle hazard lights instead, the result when used as supplied is an erratic light display.

- 1.) Use a pick tool to depress the locking tab on the terminal connector of the green/white wire
- 2.) Remove wire and prepare to reposition
- 3.) Once removed, reposition the locking tab by using a razor knife to lift the tab into a usable position
- 4.) With locking tab repositioned, relocate to pin position #1 (top right position as illustrated)
- 5.) Push the terminal connector into the I/O connector housing until the locking tab clicks into place and the wire is secure
- 6.) Correction complete, you may now complete the installation, but remember to configure POC1 for Hazards (setting #30)
