**Overview:** The initial production release of the FTI-TLK1 harness has an issue where in some vehicles the secondary power input to the CN1 connector will overload the associated vehicle circuit, causing a fuse to blow. This issue affects the initial release of harnesses and is already being addressed in production. A field correction procedure is detailed below in Figure 1.

# FTI-TLK1 Type 1B - Vehicle Coverage & Preparation Notes

# FTI-TLK1 Type 1B - Installation Notes & Wiring Diagram

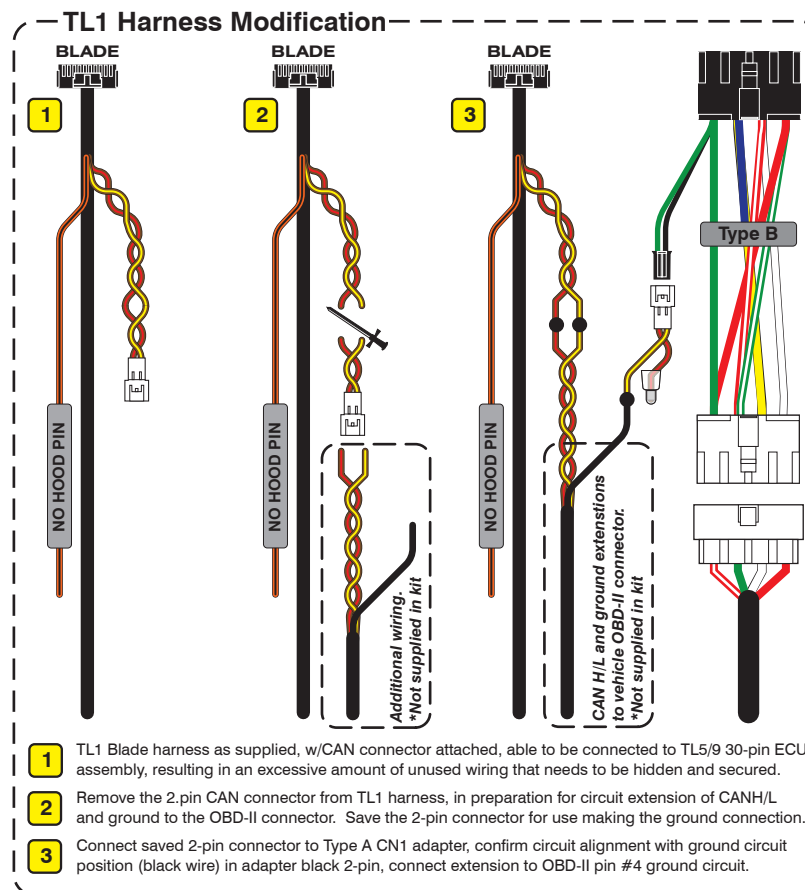
**Harness Modification (Pro Tip):** Installation with the TL1 BLADE harness requires extending a ground and CAN connections to the OBD-II connector. A slight modification to the harness is detailed below, please refer to the step-by-step procedure illustrated.
