FTI-TLP1 Type 1s - Vehicle Coverage & Preparation Notes

FTI-TLP1 Type 1s - Installation Notes & Wiring Diagram

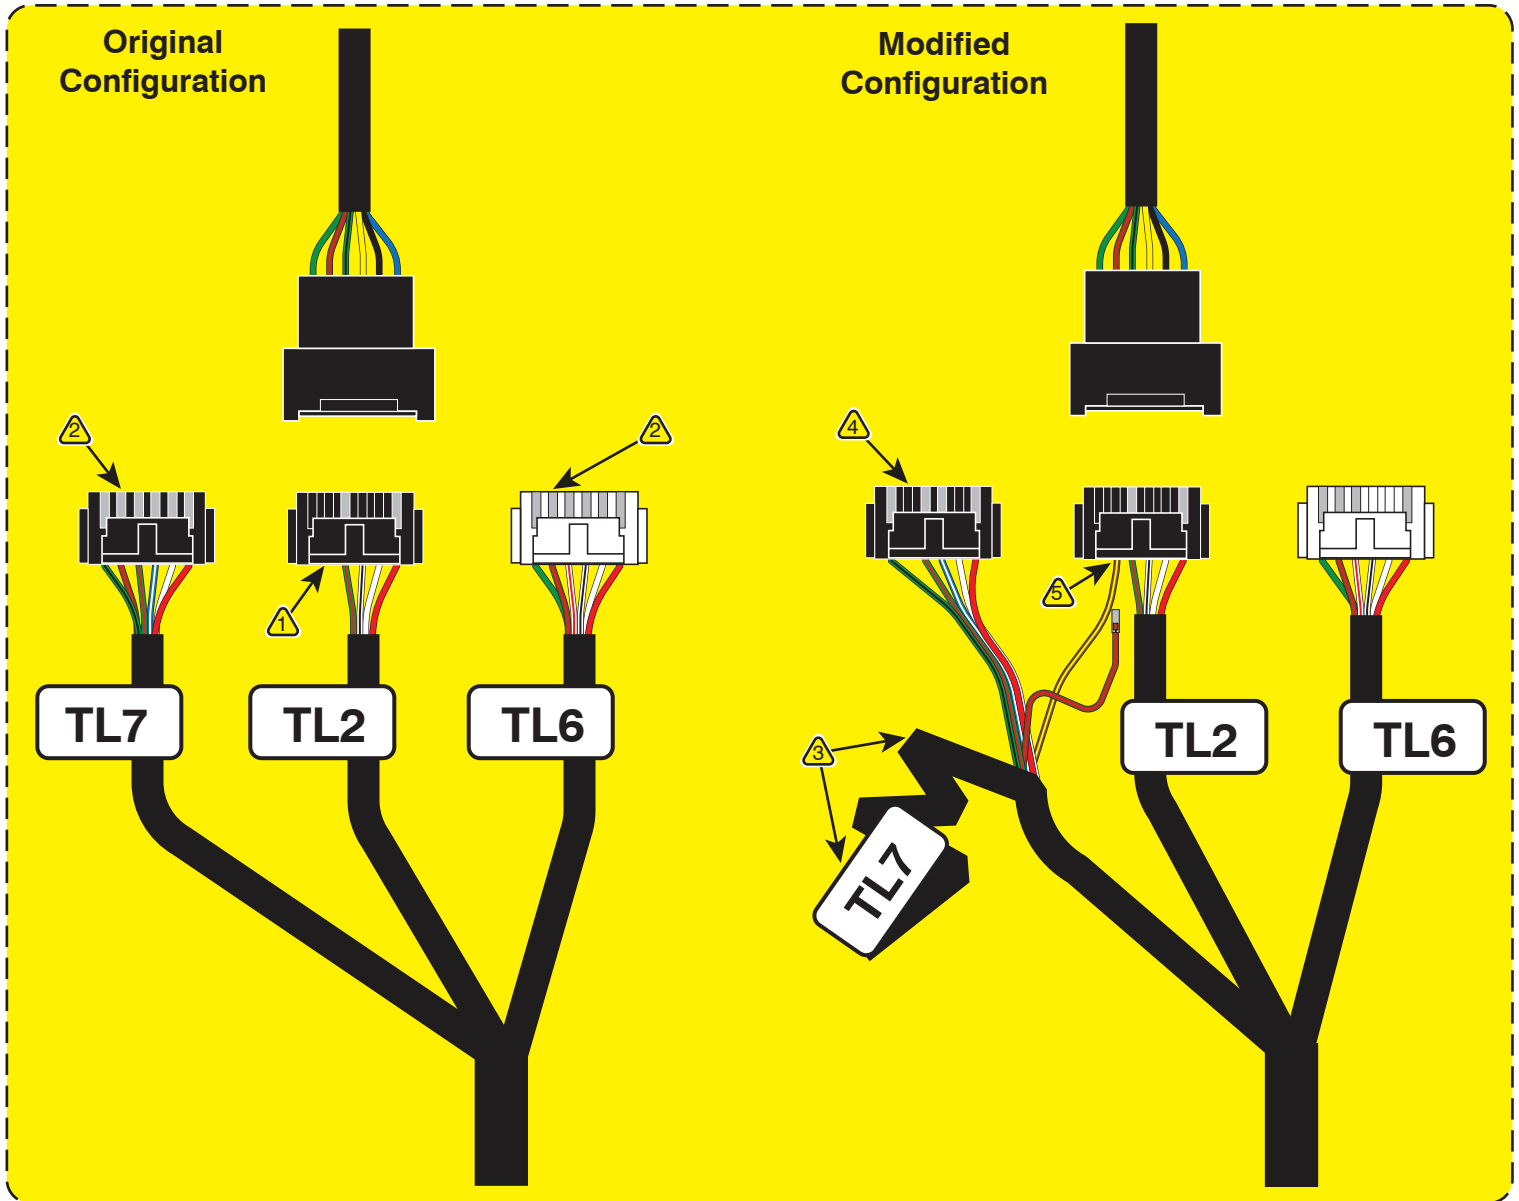
Issue: The TL2 junction connector does not include CAN connections that extend to the vehicle BCM. BCM connections are required for the 2018-19 Toyota Sienna. BCM CAN connections are available in both the TL6 & TL7 junction connectors, either pair can be relocated to the TL2 junction connector for this installation.

- 1.) TL2 junction connector with no CAN provisions
- 2.) TL6 & TL7 junction connectors with CAN provisions in pin position 2 (CANH) & position 8 (CANL)
- 3.) Remove harness covering to expose the CAN pair that you wish to relocate
- 4.) Use a pick tool to depress the locking tab on the terminal connector of the brown/yellow & brown/red wires (CANL & CANH)
- 5.) Remove each wire separately, relocate each to the matching position in the TL2 connector then secure the pair to TL2 branch

Overview: The initial release of the FTI-TLP1 harness was produced without BCM CAN provisions for the TL2 vehicles. This issue affects the initial release and is already being addressed in production. A field correction procedure is detailed below in Figure 1.
