FTI-TLP1 Type 3B - Vehicle Coverage & Preparation Notes

FTI-TLP1 Type 3B - Installation Notes & Wiring Diagram

FTI-TLP1 Type 3B

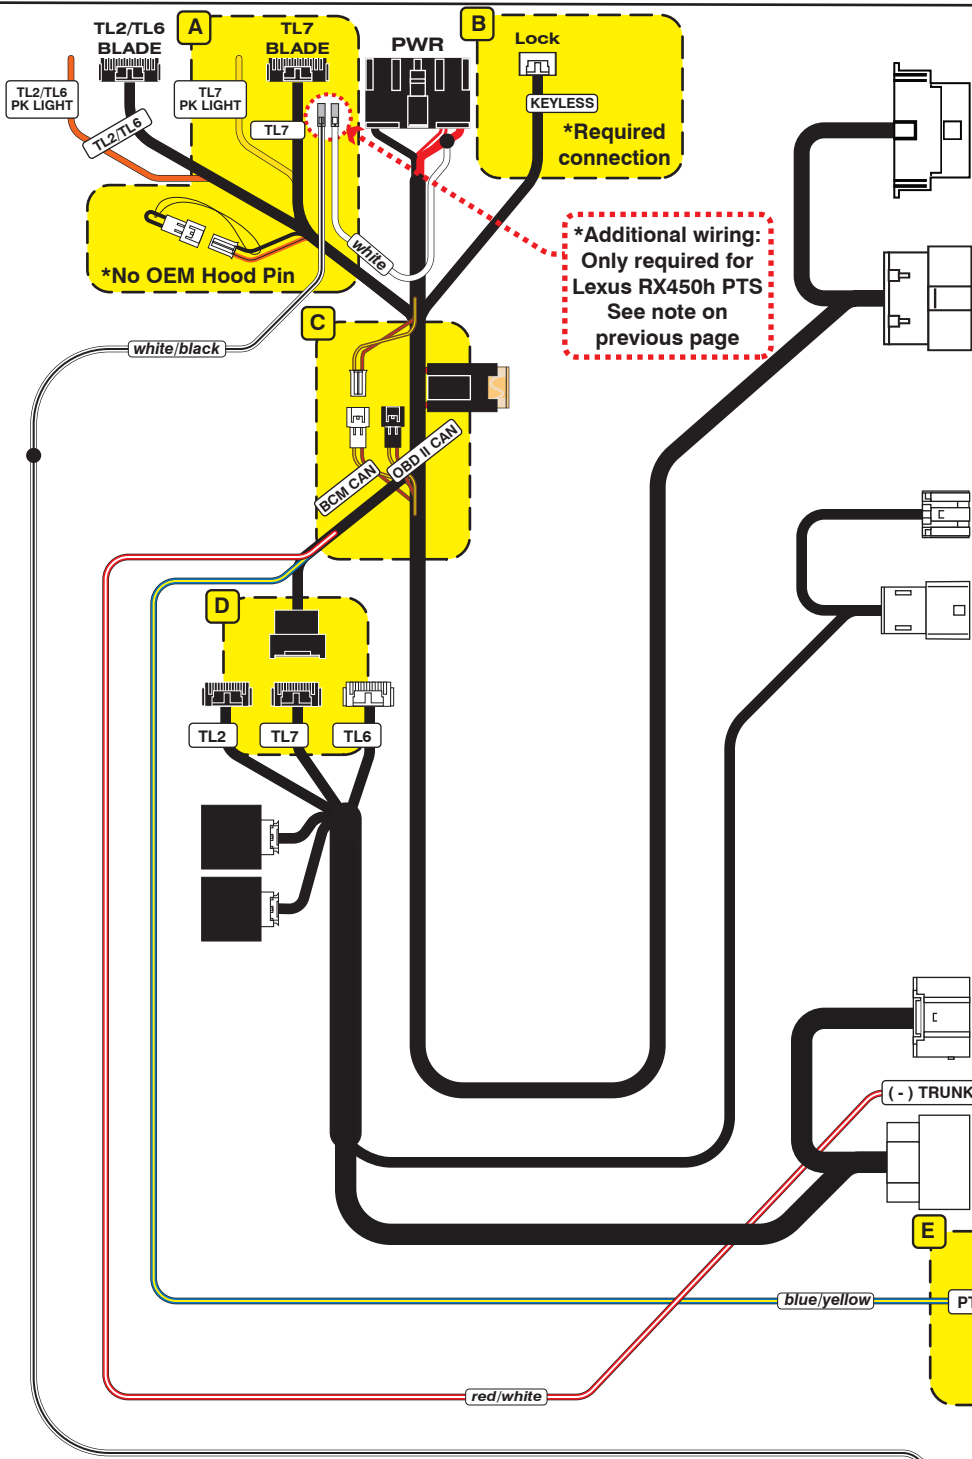
- A** Type 3B install requires using the BLADE and PK LIGHT connections marked TL7, secure unused TL2 & TL6 connections. If vehicle is not equipped with an immobilizer, connect jumper before programming.

- B** Type 3B installation requires using the 6-pin CM lock connector to maintain synchronization with the factory lock system, failure to make connection will result in malfunction and performance issues.

- C** Type 3B install sources CAN data from the vehicle BCM, use the connector marked BCM and secure the unused OBD connector for safety.
- D** Type 3B installation uses BLADE-AL(DL)-TL7 firmware and the intermediate configuration jumper marked TL7, using any other jumper will result in malfunction. Secure unused connectors for safety.

- E** PTS connection is required for IDLE MODE (allows user to exit running vehicle, enabling shutdown control and monitoring by the remote starter), connection is not required if this feature is not desired.

OBD-II Connector 1

Steering Lock Connector 2

Main Body ECU 3

PTS Button 4
