FTI-STP1 Harness Bulletin: Immobilizer Wire

FTI-STP1 Automatic Transmission Application Bulletin/Advisory F

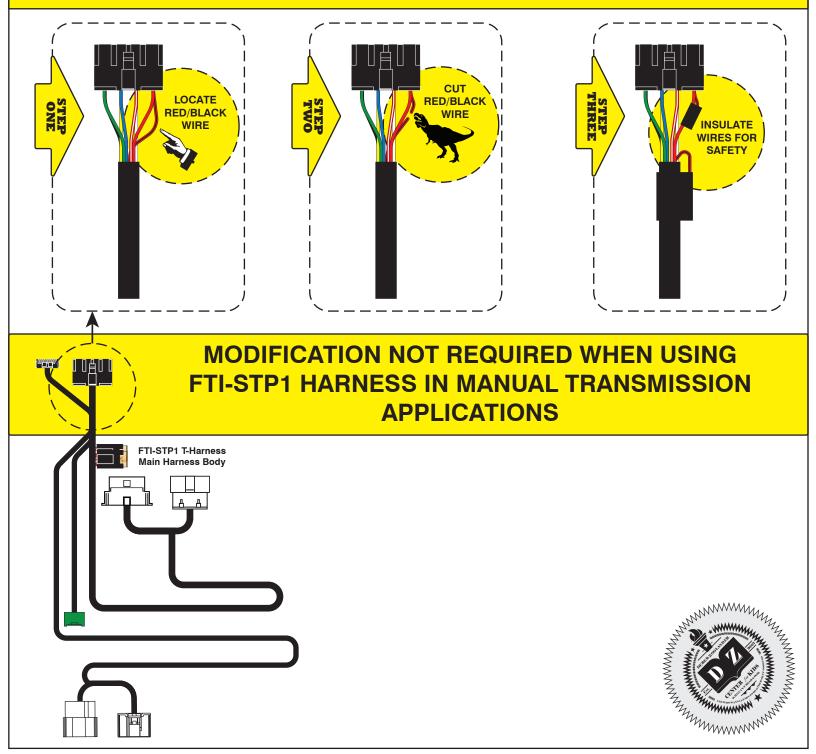
MODIFICATION REQUIRED FOR AUTOMATIC TRANSMISSION APPLICATIONS ONLY

Issue: The FTI-STP1 T-harness has been designed to be compatible with AT (automatic transmission) & MT (manual transmission) applications, but due to a production oversight, the selection mechanism was defaulted to MT mode.

Using a harness configured for an MT application, in an AT equipped vehicle, could result in vehicle module damage, it is advised that the harness be returned to AT mode before installation in vehicles equipped with an automatic transmission.

Correction: Locate the **red/black** (+ Clutch) wire provided in the CN1 connector of the main harness assembly. Cut the **red/black** wire, either flush to the CN1 connector, or leaving enough wire exposed so that you can insulate and secure the ends of the wire that remain after cutting. Insulate each of the remaining ends of the **red/black** wire and secure to prevent any possibility of a short circuit.

If the red/black wire already been disconnected, no further modification is required for AT equipped vehicles.
