### FTI-STP1 v 1.0 Harness Bulletin: Immobilizer Wire

**Overview:** Production error in version 1.0 harnesses; The immobilizer wire (orange/black) is in pin position #4 instead of pin position #5. Although an effort to correct the issue was made, some quantity of harnesses did get shipped before the issue was spotted. We are advising to inspect the harness BLADE connector before attempting to install harness or program the module. This issue is not known to affect the version 2 harnesses, which require no modification.

### FTI-STP1 v 1.0 A/T Application Bulletin/Advisory

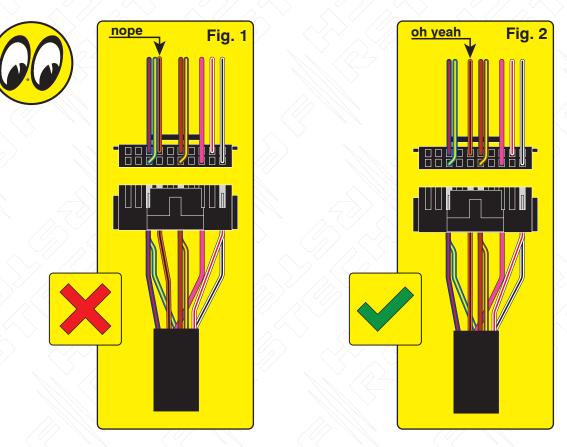
**Correction:** Step 1.) Locate the orange/black wire and confirm whether it is positioned as illustrated in Fig. 1 or Fig. 2. If the wire is as illustrated in Fig.1, proceed with Step 2 through 5 and complete the repair procedure outlined, if the wire is as illustrated in Fig. 2, correction is not necessary, proceed with harness installation and module programming.

- Step 2.) Using a pick, lightly depress the catch that secures the terminal in the housing then remove the wire and terminal from the housing.
- Step 3.) Using a fine tip razor or utility knfe, inseret the blade beneath the terminal catch and raise it slightly, so that it can be reused to secure the terminal when reinserted into the BLADE connector housing.
- Step 4.) Refer to Fig, 2 for correct position of the orange/black wire (next to brown/red) then reinsert the terminal, pressing lightly until the catch 'snaps' into place, securing the terminal in the connector housing.
- Step 5.) The repair is complete, proceed with installation and programming.
