FTI-STP1 v 1.0 Harness Bulletin: Immobilizer Wire

Overview: Production error in version 1.0 harnesses; The immobilizer wire (orange/black) is in pin position #4 instead of pin position #5. Although an effort to correct the issue was made, some quantity of harnesses did get shipped before the issue was spotted. We are advising to inspect the harness BLADE connector before attempting to install harness or program the module. This issue is not known to affect the version 2 harnesses, which require no modification.

FTI-STP1 v 1.0 A/T Application Bulletin/Advisory

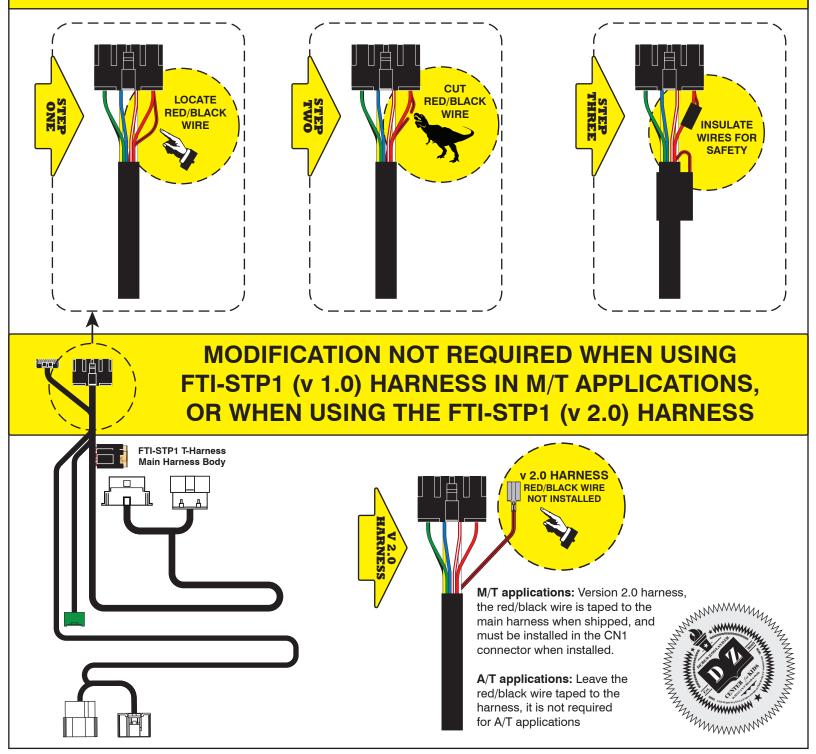
MODIFICATION REQUIRED FOR A/T APPLICATIONS, ONLY WITH v 1.0 HARNESS

Issue: The FTI-STP1 T-harness has been designed to be compatible with A/T (automatic transmission) & M/T (manual transmission) applications, but due to an oversight in early production runs, the selection was defaulted to M/T mode.

Correction: Locate the **red/black** (+ Clutch) wire provided in the CN1 connector of the main harness assembly. Cut the **red/black** wire, either flush to the CN1 connector, or leaving enough wire exposed so that you can insulate and secure the ends of the wire that remain after cutting. Insulate each of the remaining ends of the **red/black** wire and secure to prevent any possibility of a short circuit. **If the red/black wire has already been disconnected, no further modification is required for A/T applications**
